# KGT R-15

## Frequency Domain Reflectometer

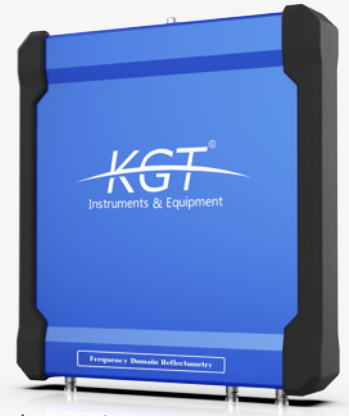
The R-15 Frequency Domain Reflectometer is a small, lightweight, high-speed device that quickly and accurately locates cable faults in complex environments such as the laboratory or the field. It obtains the cable impedance spectrum data by injecting the sweep signal into the cable, and uses signal processing and algorithms to locate faults. Using the accompanying test software makes the diagnosis process faster and easier. Just connect the device, set the parameters, connect the cable for diagnosis, and in a few minutes, you can easily locate the fault. The product provides an accurate and reliable solution for cable fault location.

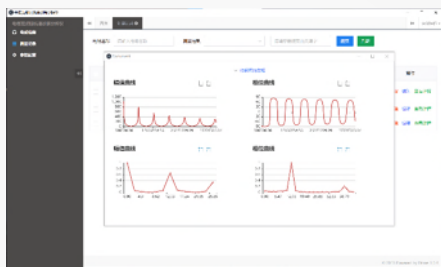
The software is easy to use with a simple and intuitive user interface that does not require expert knowledge.

The built-in intelligent diagnosis and positioning algorithm can automatically form a cable defect location map.

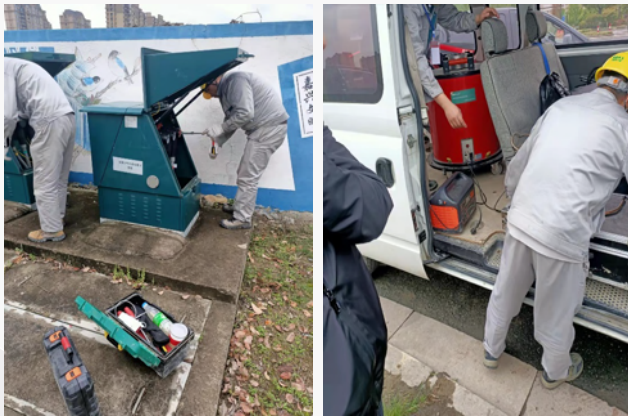
(a) Comparison of local emission detection of oscillating wave

This project successfully located the discharge point in the line based on the cable defect location technology of impedance spectrum and compared the location results with that of the oscillating wave partial discharge detection method (319m). It was found that the two results were relatively close, and the cause of discharge was found to be the abnormal T connection box of the cable in the middle position.

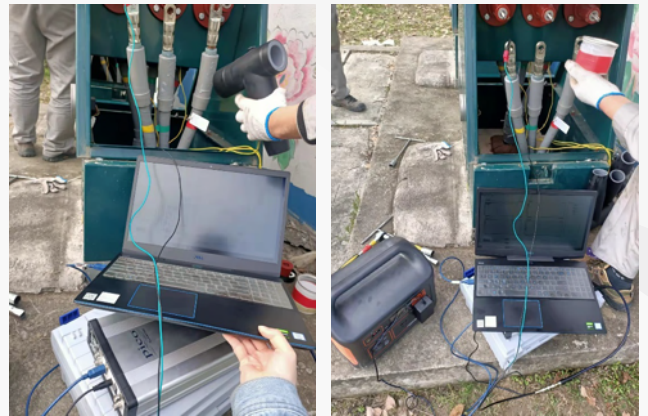
(b) Cable defect location based on FDR

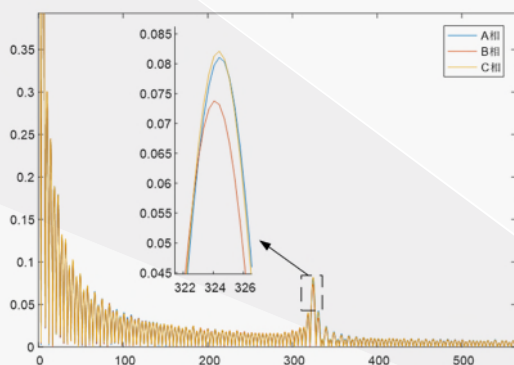
(a) Impedance amplitude spectrum location curve

The positioning results based on the impedance amplitude spectrum are all around 324m, and the positioning results based on the impedance phase spectrum are all around 328m, which is close to the results of the oscillating wave partial discharge detection method 319m.

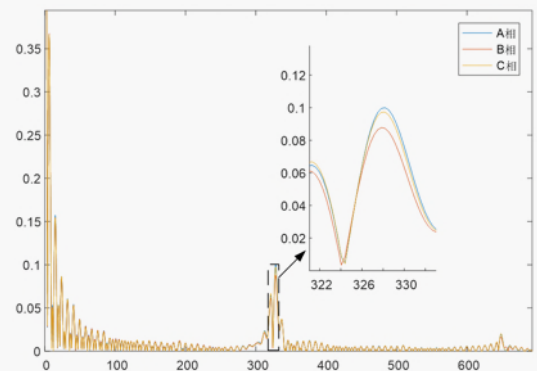
(b) Impedance phase spectrum positioning curve

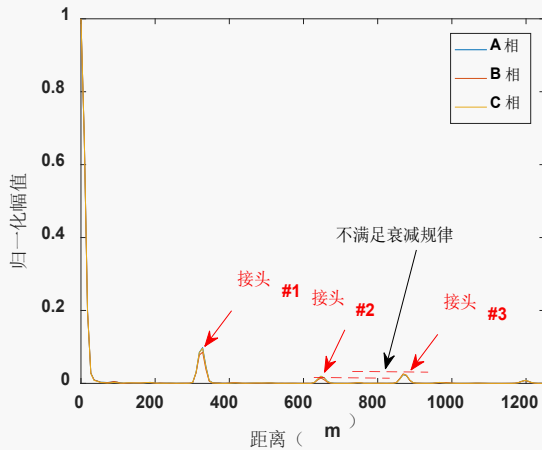
(a) Test curve

The field test was conducted on June 4, 2022. The total length of the cable is 1205m and there are three intermediate joints. In the test results, it is found that the positioning amplitude of joint #3 exceeds that of joint #2, which does not meet the attenuation law. It is found to be a damp defect after disintegration.

Based on the detection curve, it can be seen that the curve of the joint position obviously does not meet the attenuation law, so it can be judged that there is a defect of aging or water intake at the joint position. The accuracy of the test system of the cable broadband linear impedance spectrum was verified after the disassembling of the defect position in the later period.

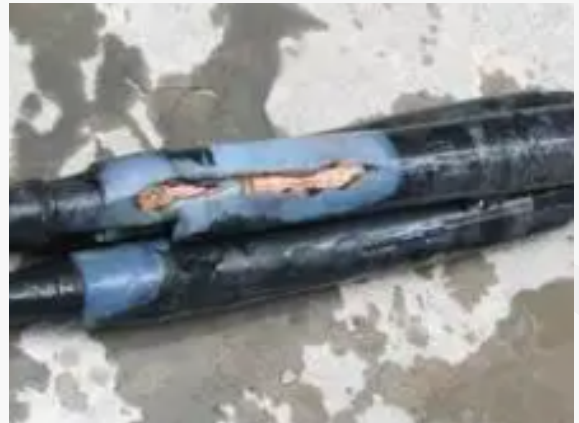
(b) Damp defect
